SUPPLEMENT TO: **ENGINE
BUILDER** MAGAZINE

TECH SOLUTIONS

guide

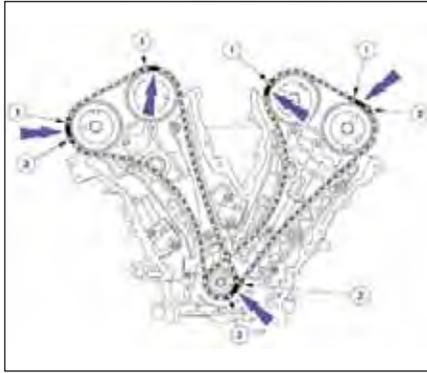
If you have to remove or replace a cylinder head for any reason, or replace the timing chain on a 3.0L Duratec, it can be a bit of a challenge because Ford doesn't provide a Top Dead Center (TDC) timing reference mark on the crankshaft.

Figure 1 You will have to use a dial indicator to find the TDC position of the number one cylinder on Ford's 3.0L Duratec to make sure the crank and camshafts are all properly aligned.

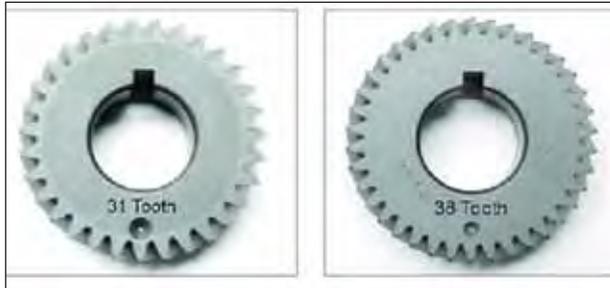
The drive and driven gears of the balance shaft appear to have changed in August of 2003 for vans and August of 2004 in the truck. The driven gear on the balance shaft

Figure 2 Ford increased the number of teeth in the drive and driven gears on several Ford engine balance shafts in 2003 and 2004.

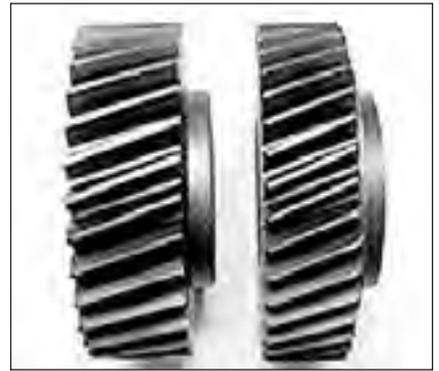
Figure 3 It's easy to confuse the two gears, but putting the wrong driven gear into a Ford engine will cause real problems.

The change in teeth was to further reduce the NVH of the gears that drive the balance shaft. Obviously a mix up would result in a catastrophic failure. However, what I have found is that as long as you keep the camshaft drive gear and balance shaft gear matched it makes no difference which ones you use.

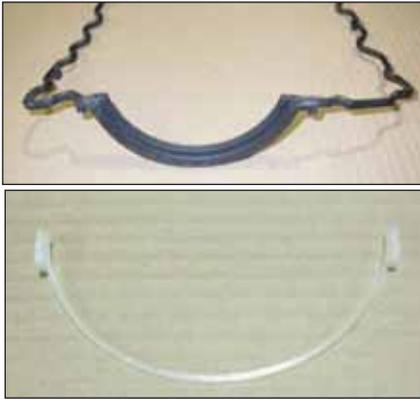
The most common oil leak on '90-'93 4.0L engines is often diagnosed as a rear seal leak, but in most cases, the problem is usually found to be the rear of the oil pan gasket. Since 1990, when the 4.0L was first introduced, Ford redesigned the gasket twice and even the oil pan casting to eliminate the leaking issue.

Figure 4 The oil pan gasket for the '90 to '93 4.0L Ford engine (top) will include a plastic wedge seal (bottom) that goes into a groove in the main cap

The following installation tips from Canada Engines should help to prevent this costly and aggravating oil pan gasket leak.

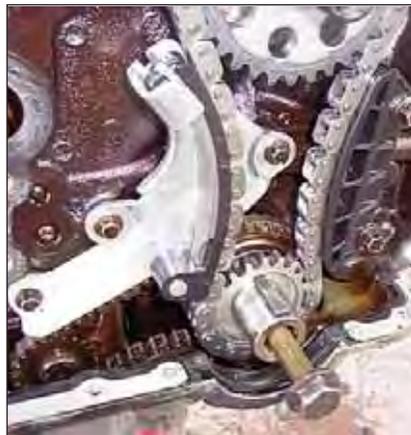
The noise is audible during hot and cold engine operation (but predominantly found on cold engines) under acceleration, typically at 2,400-2,500 rpm. To confirm presence of this noise, accelerate in 2nd gear between 2,000-3,000 rpm and listen for a rattle noise that sounds similar to spark knock. This may be caused by the primary timing chain tensioner system.

Figure 6 The patented "Offset Y-drive" uses three timing chains, one from the crank to the jackshaft, one in the front of the engine to drive the cam for the left bank and one on the back of the engine to drive the cam for the right bank.

Replace the primary timing chain tensioner, chain guide, jackshaft, and crankshaft sprockets with a primary timing chain tensioner kit. The kit includes an improved primary chain Tensioner, as well as updated primary chain guide, jackshaft, and crankshaft sprockets. Required fasteners, primary timing chain, and front cover gaskets are also included.

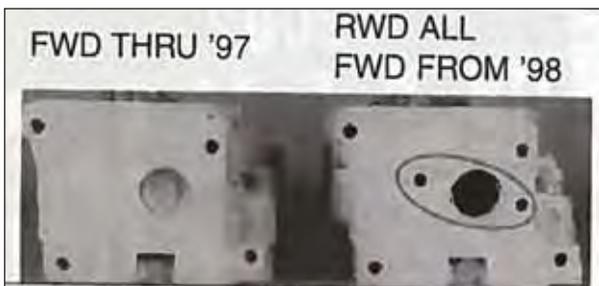
The FWD version requires the use of a 34.4 mm soft plug in front of the head while the RWD model is open and must have the bolt holes drilled and tapped (see **Figure 1**). The 1994 motor could have casting number 10112391 or 10112391S that is the service replacement. This same pattern was followed throughout

Figure 1 The FWD 2.2L engine (left) requires the use of a soft plug in the front of the head. The RWD model is open and must have the bolt holes drilled and tapped.

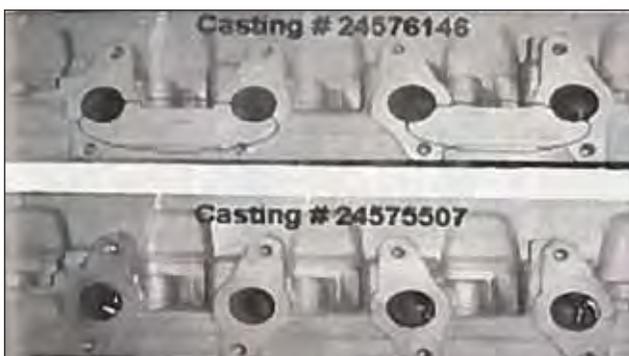
two and last two exhaust ports (see **Figure 2**). The latest exhaust manifolds have a balance channel that runs between ports 1-2 and ports 3-4 that must seal against the cylinder head. As you can see, that exhaust manifold configuration assembled against the 507 head would leak.

Figure 2 The GM 2.2L cylinder head in use since 1999 has long flat bosses between the exhaust ports (top). The latest exhaust manifolds have a balance channel that runs between ports 1 - 2 and 3 - 4.

One last quirk: the 146 head may also be drilled for the EGR port as a service replacement for the 507 head in 1998. All later applications would require the use of an EGR block-off plate (GM p/n 24575919) when used without EGR.

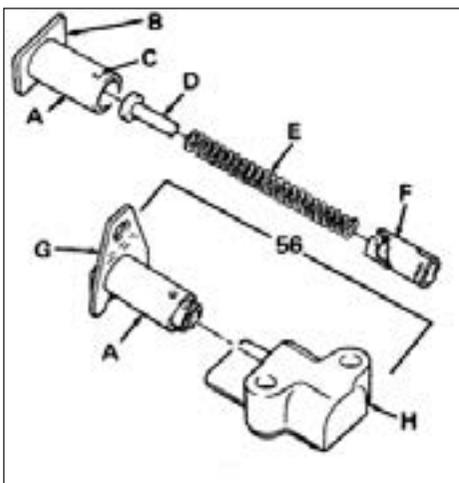
Inadequate tension placed on the chain will eventually result in chain breakage and the consequential piston to valve contact.

Failure to perform this important final step can lead to severe engine damage.

Figure 3 GM 2.3L Quad 4 Timing Chain Tensioner Assembly. This is the late production piece, although early production is similar. Components include: A. Plunger assembly; B. Long end; C. Peg; D. Nylon Plug; E. Spring; F. Restraint cylinder; G. J-36589 Anti-release device; H. Tensioner body.

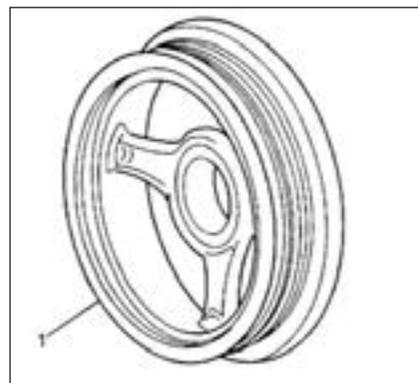
If a whine, ringing or whistling noise is reported in several 3.6L Cadillac engines, replacement of the crankshaft harmonic balancer is recommended if

Figure 5 Refer to the above graphic illustration and inspect the crankshaft harmonic balancer for design type. After the inspection, if the vehicle was built with three spoke (1) design crankshaft harmonic balancer; replace the harmonic balancer with p/n 12597654.

crankshaft harmonic balancer to determine the design type. If the vehicle was built with a three-spoke design crankshaft harmonic balancer, replace the harmonic balancer with a new unit (P/N 12597654.)

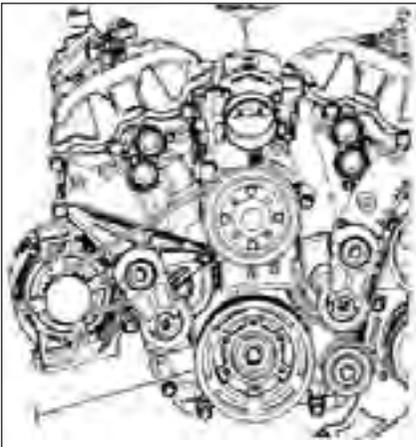
Figure 6 Refer to the above graphic illustration and if the vehicle was built with the NEW DESIGN six spoke (1) crankshaft harmonic balancer, DO NOT replace it. Continue on with routine diagnosis to isolate the noise.

However, if the vehicle is equipped with the V03N92 Heavy Duty Cooling package, DO NOT replace the six-spoke design crankshaft harmonic balancer (see **Figure 6**). Continue with routine diagnosis to isolate the noise.

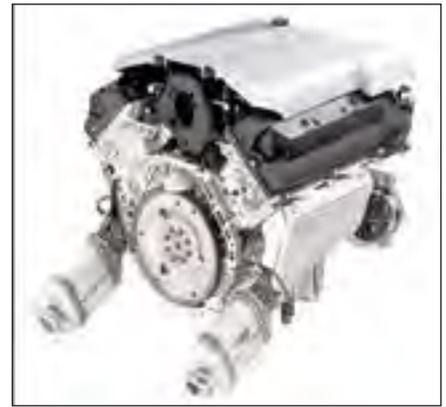
This new-style converter provides quick catalyst warm-up, resulting in lower tailpipe emissions earlier in the operating cycle. If an engine failure occurs (such as a broken intake/exhaust valve or piston), debris may be deposited in the converter through the engine exhaust ports.

If the engine failure is due to a severe overheating event, damage to the ceramic "brick" inside of the catalytic converter may occur. This could then result in ceramic debris being drawn into the engine through the cylinder head

If a replacement engine is installed due to either of these instances, the replacement engine may ultimately fail due to the debris being drawn into the combustion chamber upon startup.

Figure 7 Certain late model General Motors vehicles may be equipped with a new style of catalytic converter, technically known as the close-coupled catalytic converter. Engine failures can damage the converters which, if not inspected properly, can then cause subsequent damage to a replacement engine.

Remind your installers that when they replace an engine due to a failure of this type, they must inspect the converters and ALL transferred components such as the intake and exhaust manifolds. Remove any debris that is found.

In cases where engine failures occurred as a result of severe overheating, installers should inspect each catalytic converter for signs of melting or cracking of the ceramic "brick." If damage is observed, the converter should be replaced.

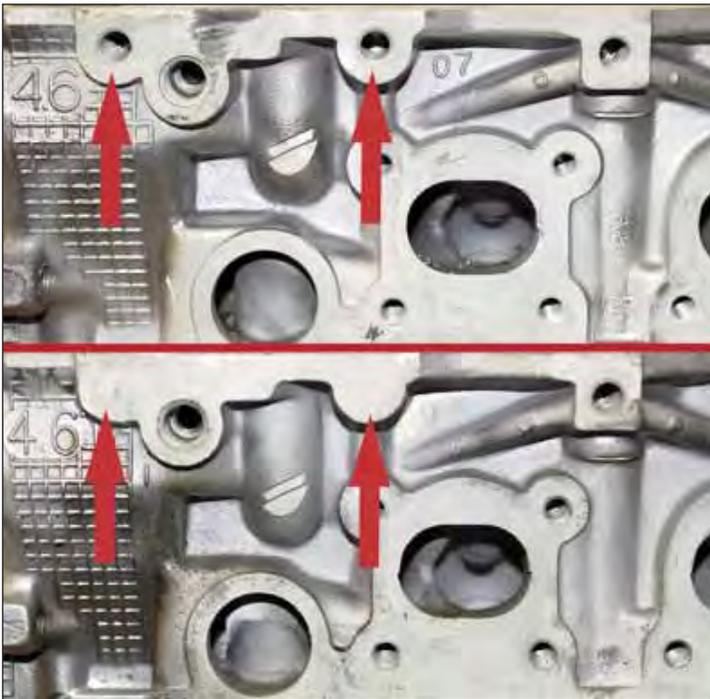
Figure 9 The cylinder head on the top has the bolt holes drilled and tapped for the alternator bracket when used. The head below does not but both have the same casting number. To avoid potential warranty issues drill and tap all heads.

If you want to avoid problems I recommend that you drill all of the bosses, thereby eliminating the possibility of having a warranty problem upon installation and also reducing head proliferation.

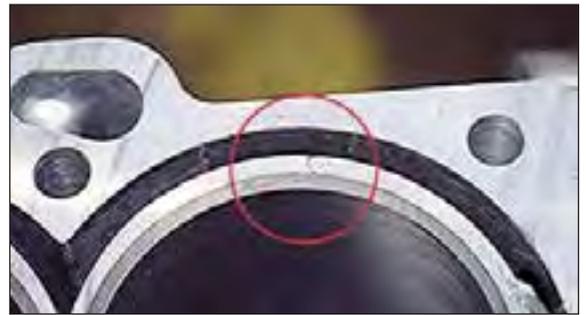
Cadillac 4.6L DOHC engines may be prone to cracking of the aluminum block casting around the cast iron liner

Figure 8 The aluminum 4.6L Cadillac block may crack outside the cast iron cylinder liner and is extremely hard to detect. The above crack became visible only after the deck face was machined.

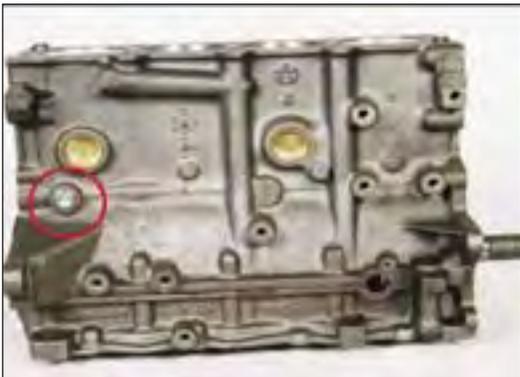
Figure 1 The hole for the oil sender on the passenger side of the 2.4L was moved back about 6" in 2001 so it's much closer to the bell housing

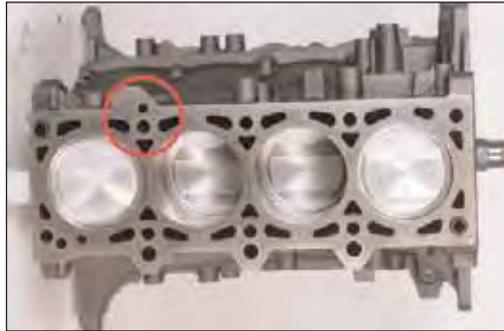
Figure 2 The oil drainback hole in the head on the 2.4L was enlarged in 2002, so the block had a pronounced bulge on the driver's side between the third and fourth cylinders.

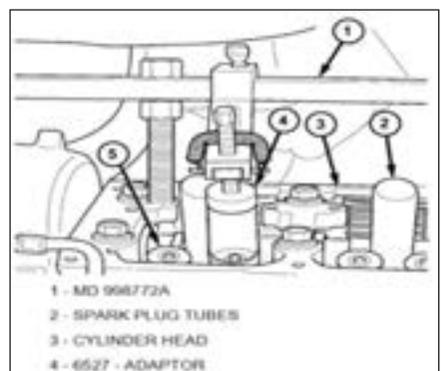
The misfire condition may be caused by one or more engine exhaust valves that are slow to close due to a buildup of carbon on the valve stem.

1. This condition may occur when the engine is not allowed to run at engine rpms that are greater than 3,500. At 5,000 rpm or higher, the engine exhaust valves will rotate if not impeded by high carbon deposits. Low engine rpms and high carbon deposits are associated with short-trip driving where the engine is not allowed to fully warm to normal engine operating temperatures.

Figure 3 Using a valve spring compressor tool with the valve spring adapter, slightly compress the exhaust valve spring to release tension against the valve and valve spring retainer on 3.5L engines.

- 1) Relieve the fuel pressure.
- 2) Remove the upper intake manifold.
- 3) Remove the cylinder head cover(s).
- 4) Remove the rocker arm and shaft assembly.
- 5) Clean and mark the tip of each exhaust valve stem at the 12 o'clock position with a paint marker. The paint mark will be used later to assist with determining the amount of valve rotation.
- 6) Remove the spark plugs.
- 7) Rotate the crankshaft clockwise, until the number 1 piston is at Top Dead Center (TDC) on the compression stroke.
- 8) Install the compression tester spark plug adapter in cylinder #1 spark plug hole. With the air hose attached to the spark plug adapter, apply 90 to 100 psi air pressure. This is to hold the valves

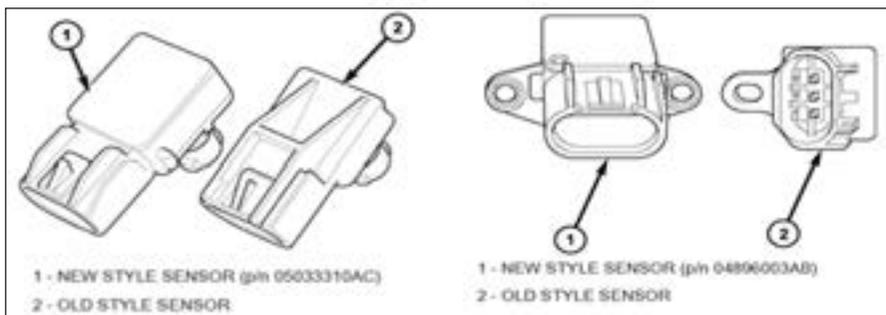
Figure 4 Inspect the MAP sensor for LX models (left) or for CS models (right). If the MAP sensor is the new style, no further action is necessary for the MAP sensor.

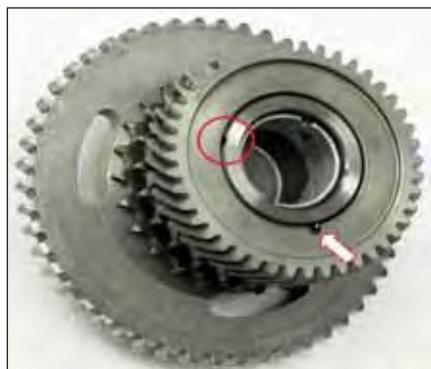
Figure 5 The circle shows where the roll pin (arrow) and spline gear should be aligned for proper timing of the balance shaft on the 3.7L. This assembly has spun on the center shaft over 90 degrees.

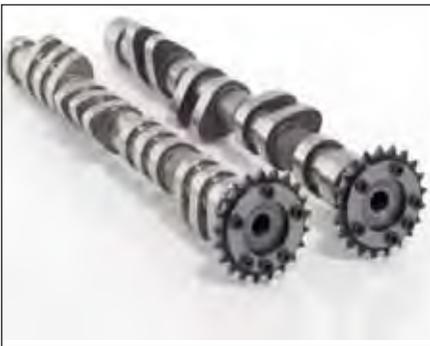
Figure 1 Dimensional differences between the camshaft sprockets and the cam timing chain may create a rattling noise on some Volkswagen 16-valve engines that can be heard from the cylinder head at approximately 2,000 rpm.

Intake cam p/n: 027 109 021 AJ
Exhaust cam p/n: 027 109 022 F

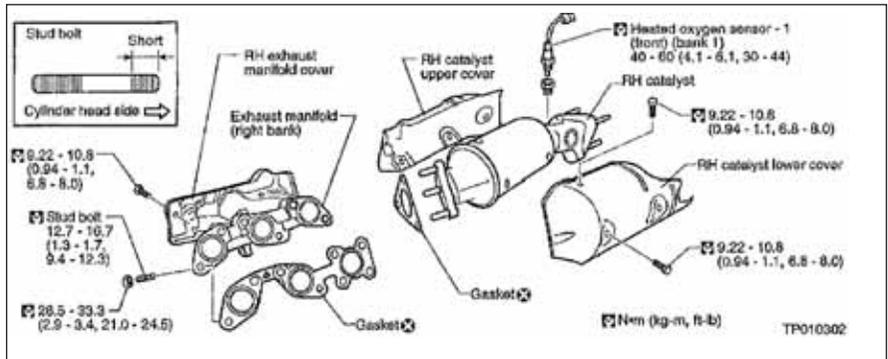
Figure 3 A ticking noise may be heard from a cracked exhaust manifold on certain Nissan engines. Typically, inspection for cracks between the #1 and #3 ports should be conducted.

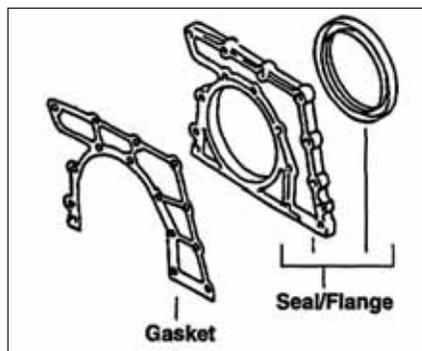
Figure 2 When replacing the oil seal on 1996 Audi A4 models with V6 engines, make sure the new seal is supplied pre-installed in the flange.

- 1) Carefully remove installation

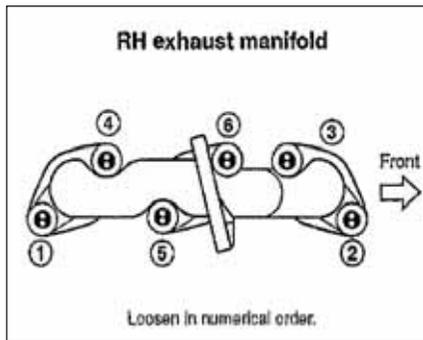
Figure 4 Sequence for loosening the exhaust manifold nuts on the Nissan VG33E.

- 2) Remove the exhaust manifold from the head (See **Figure 4** for loosening sequence of manifold nuts). NOTE: If any of the nuts or studs are damaged during removal, replace them

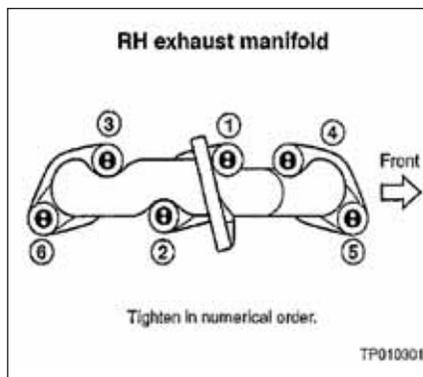
Figure 5 Sequence for tightening the exhaust manifold nuts on the Nissan VG33E.

4) Re-attach the catalyst to the exhaust manifold. NOTE: Ensure that
