CHRYSLER

Camshaft Sprocket Service for 1994 2.0L DOHC Engines

Intermittent Valve Train Ticking Noise on Hot Or Cold 1990 3.0L Engines

Engine Spark Knock On 2004-'06 3.3L Engines

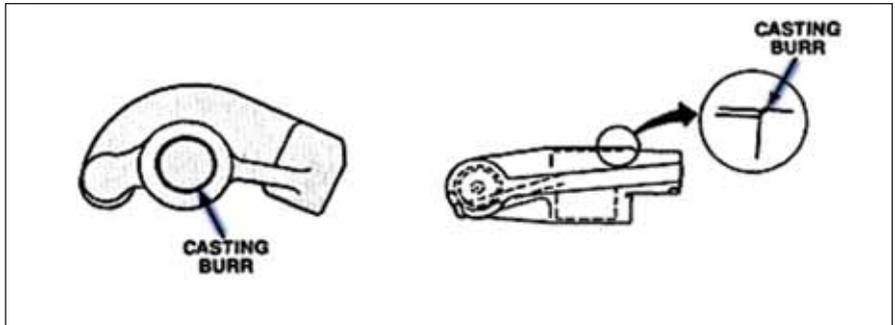
Some 1990 3.0L engines built before engine code 7-370 may exhibit a valve train ticking noise. This noise can occur when the engine is cold and/or at operating temperature. This condition may be the result of a rocker arm casting burr in the area of the rocker arm shaft bore.

With the engine running, use a stethoscope to pinpoint the noise location by listening at the right and left (front and rear) cylinder head covers. Turn the engine off, and remove the appropriate cylinder head cover. Carefully move the rocker arms, one at a time, away from the cam shaft bearing cap. Inspect the rocker arm surface that contacts the cam shaft bearing cap for cast-

ing burrs as shown in **Figure 2**, below. If casting burrs are found, perform the repair procedure listed below.

Figure 2 Inspect the rocker arm surface that contacts the cam shaft bearing cap for casting burrs. If casting burrs are found, perform the repair procedure.

This repair involves the removal of the rocker arm assembly, removal of the rocker arms from the shaft and removing the casting burr from the rocker arm(s).

paper soaked in oil, remove the casting burr from the rocker arm. The rocker arm surface should be smooth and free of burrs.

3) Thoroughly clean the rocker arm to remove all traces of the abrasive material.

4) Clean the rocker arms and rocker shafts and reassemble as outlined in the appropriate Service Manual.

5) Install the rocker arm assembly.

6) Tighten the rocker arm bearing cap bolts to 85 in.lbs. (10 Nm) torque in the sequence outlined in the appropriate Service Manual.

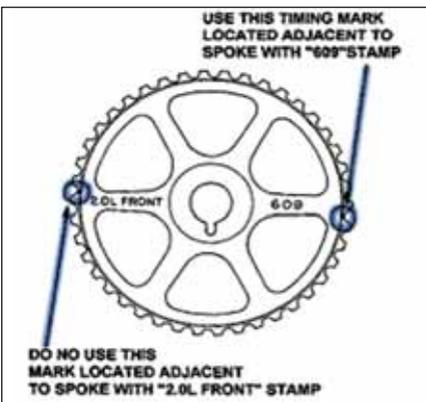
The camshaft sprockets on the 2.0L DOHC engines built Aug. 1, 1994 through Oct. 31, 1994 may have two timing marks on the 2.0L side of each sprocket (see **Figure 1**, below).

Engine damage may result from incorrect installation of either camshaft sprocket after an engine repair.

It is important that the correct timing mark is used when setting the cam timing. If the wrong timing mark is used, the valves may come into contact with the pistons resulting in engine damage.

Figure 1 1994 2.0L engines may have two timing marks on the 2.0L side of each sprocket.

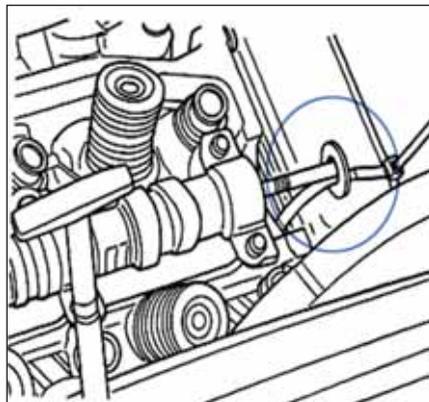
Figure 3 Feed the tie strap through the washer and attach to the engine.

2) Install the 1/2" washer on the bolt and install the bolt in the hole in the rear of the camshaft. Feed the tie strap through the washer and attach to the engine as follows: Front (left) cylinder head, route strap around exhaust pipe and pull strap tight (**Figure 3**, below).

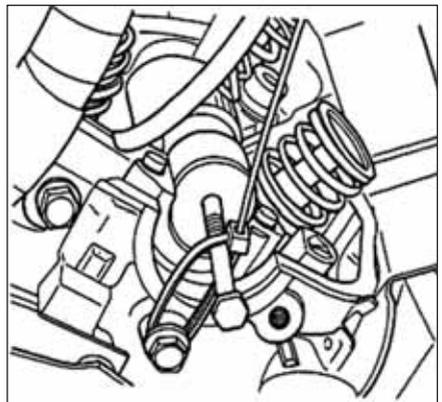
Figure 4 Install the M8 bolt on rear of the block, route strap around the bolt and pull strap tight.

Rear (right) cylinder head, install the M8 bolt on rear of the block, route strap around the bolt and pull strap tight (**Figure 4**, below).

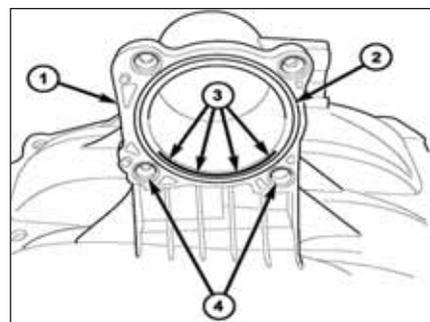
Whistling sounds have been reported coming from some 2007 Chrysler 3.7L engines. The intake-to-throttle-body joint may be the cause of the "whistle-like" sound.

Figure 6 Apply RTV to the lower section of the joint between the lower two throttle body bolt attachment holes.

8). A very small amount of RTV is needed to seal the slight space/gap on the inner surface of the joint. The gap was created by a slight taper in the intake manifold joint surface. Do not apply an excessive amount of RTV to the joint. And do not over-torque the throttle body bolts, as it may cause damage to the throttle body.

2) Apply a very small diameter bead (1 mm) of RTV to the intake manifold-to-throttle body joint. The RTV is to be applied to the lower section of the joint between the lower two throttle body bolt attachment holes (**Figure 6**, page

3) Install the ETC throttle body to the intake manifold. Tighten the throttle body's four attaching bolts to 60 in.lbs. (7 Nm). Wipe off inside joint of any excess RTV that is squeezed out.

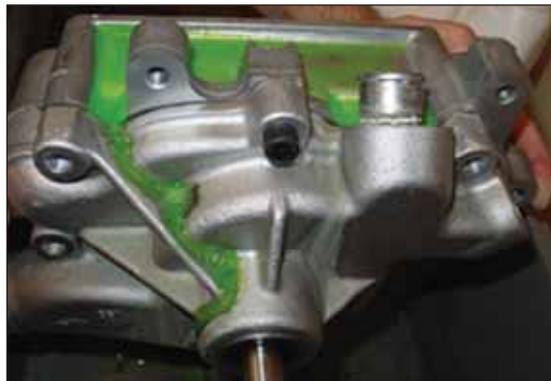
Figure 7 Coolant rolls across the front of the pump and behind the pulley, making it appear to leak from the weep hole.

A coolant leak from a source above the water pump or from an improperly installed bypass tube on the water pump itself will cause coolant to pool on top of the timing cover. This coolant then rolls across the front of the pump and behind the pulley, making the pump appear to leak from the weep hole (**Figure 7**, above). This often results in unnecessary pump replacement.

When replacing this pump, the supplied bypass tube should be installed with thread sealant and should be prop-

erly tightened before installation of the pump. The bypass hose and clamp should be inspected for wear, holes or other flaws before they are reused and the area should be inspected for evidence of

other leaks, such as from the thermostat housing. The original leak that prompted the pump to be changed may still be present and will need to be addressed.

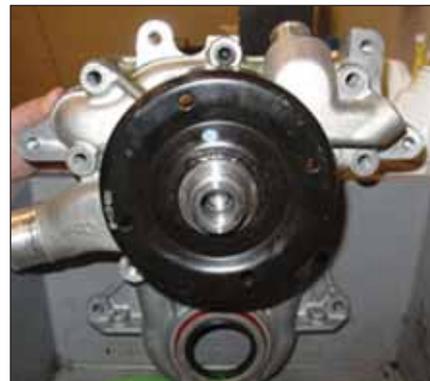
The pulley on this pump completely covers the face of the pump, making the correct diagnosis difficult (**Figure 8**, above). The bypass tube that is shipped loose in the box is often installed without sealant or is not tightened properly. The subsequent leak can cause antifreeze to gather on top of the timing cover, which is difficult to see. There are other components above the water pump, including the thermostat housing and the bypass hose, that can leak and cause antifreeze to gather in the same place and eventually mimic a leaking water pump.

Figure 8 The pulley completely covers the face of the pump, making the correct diagnosis difficult.
