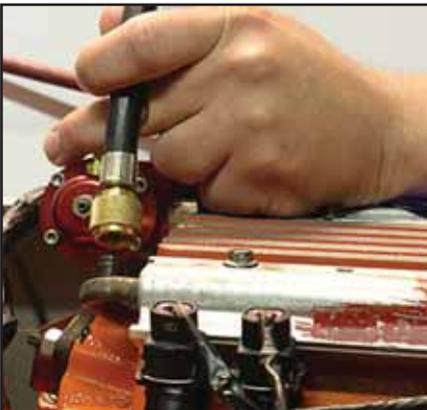
**Figure 1** Screw the fuel pressure gauge onto the Schrader Valve located on the fuel rail.

Step #1 - You will need to screw the fuel pressure gauge onto the Schrader Valve that is located on your fuel rail, (Figure 1, below) make sure that it is tight to avoid any leaks and or fires. Once the gauge is installed turn the ignition key to the on position and check for leaks at the Schrader Valve.

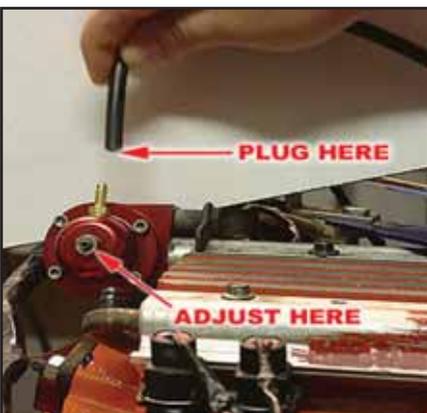
**Figure 2** Plug the rubber vacuum line so it does not leak while making adjustments.

Step #2 - Start the engine and let the idle level off and then disconnect the vacuum line that goes to the regulator (Figure 2, below), make sure that you plug the rubber vacuum line so it does not leak vacuum while you are making the adjustment, (you only care about the fuel pressure reading with the vacuum line disconnected at idle).

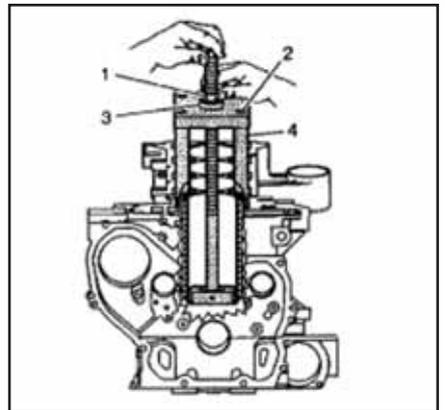
**Figure 3** Install cylinder bore sleeve puller (p/n EN 45680-852).

4) Install cylinder bore sleeve puller (p/n EN 45680-852) through the cylinder bore (Figure 3, below). You must ensure that the shoe is flat against the bottom of the cylinder bore liner or damage to the cylinder bore liner puller will result.

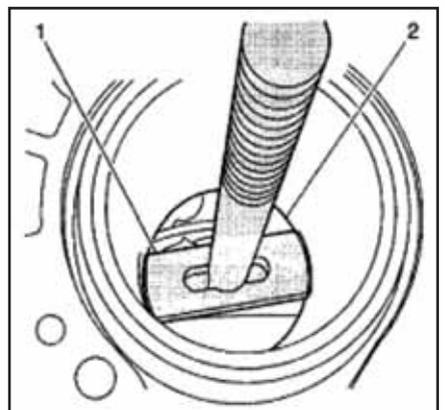
**Figure 4** Align the shoe (1) of the puller to the bottom of the cylinder bore sleeve (2).

5) Align the shoe (1) of the puller to the bottom of the cylinder bore sleeve (2), (Figure 4, below).

7) Install the fixture (item 4 in Figure 4), EN 456850-851 onto the threaded shaft of the puller (EN 456850-9852) and engine block.

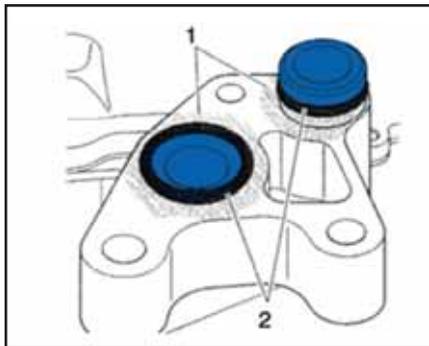
The leak is caused by minor imperfections in the engine block machine surfaces at the oil cooler interface that may allow engine oil seepage past the oil cooler O-rings. To cure this problem, GM offers the following information:

**Figure 6** Install new O-rings (2) to the oil cooler on 6.6L Duramax diesel engine.

5) Install new O-rings (2) to the oil cooler (**Figure 6**, left).
