SUPPLEMENT TO: **ENGINE
BUILDER** MAGAZINE

TECH SOLUTIONS

guide

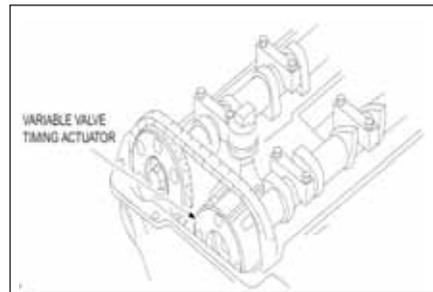
Figure 6 Location of the variable valve actuator for the Mazda MZR engine.

2) After the engine cools down, replace the variable valve timing actuator.

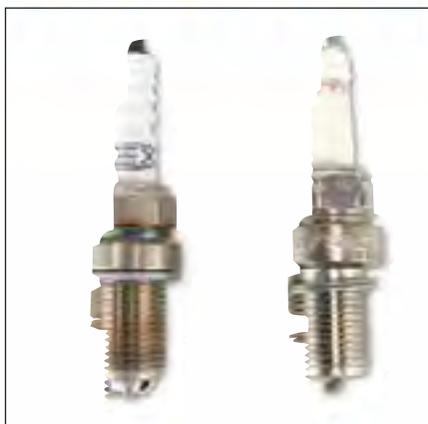
Figure 1 As a rule of thumb, you can expect to require one heat range colder than the factory-supplied plugs for every 75-100 horsepower you've add with your modifications.

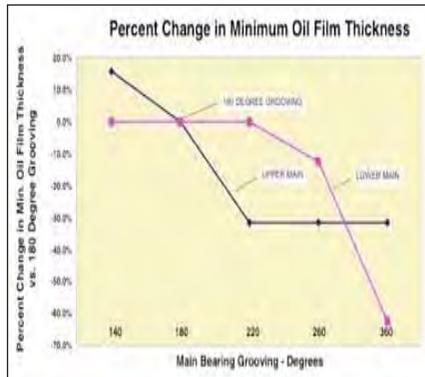
In an effort to develop the best possible main bearing designs for high performance engines, manufacturers have investigated the effects of main bearing grooving on bearing performance. The graph (Figure 2) illustrates that a simple 180° groove in the upper main shell is still the best overall design.

Figure 2 As engine and bearing technology developed, the bearing grooving was removed from modern lower main bearings creating a thicker oil film.

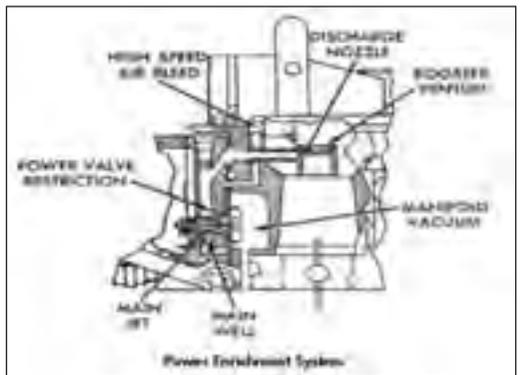
An accurate vacuum gauge should be used when determining the correct power valve to use. A competition or race engine which has a long duration high overlap camshaft will have low manifold vacuum at idle speeds. If the vehicle has a manual transmission, take the vacuum reading with the engine thoroughly warmed up and at idle.

If the vehicle is equipped with an automatic transmission, take the vacuum reading with the engine thoroughly warmed up and idling in gear. In either case, the power valve selected should be half the intake manifold vacuum reading taken.

Figure 3 Holley carbs use a vacuum operated power enrichment system and a selection of power valves is available to "time" this system's operation to your specific needs

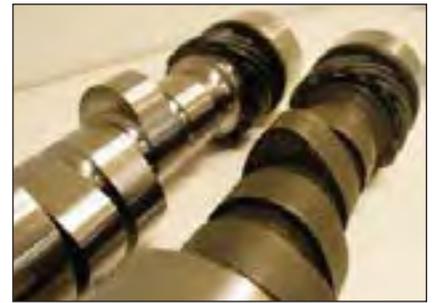
- Longer duration cams require tighter lobe separation to have any power off the corner (not usually a preferable combination in 2 bbl classes). Shorter duration cams with wider lobe separations usually yield much flatter torque curves. Longer rod engines seem to prefer shorter durations and wider lobe separation (**Figure 4**).

Figure 4 Longer rod engines seem to prefer shorter durations and wider lobe separation.

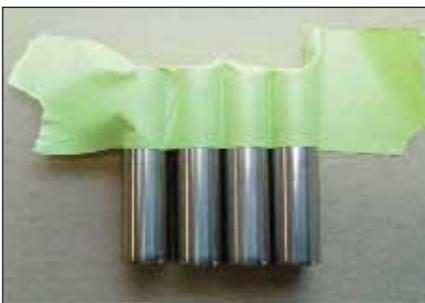
Figure 1 It's often difficult to see when installing guides in OHC heads. Mark with graphite spray for correct depth.

out all the guides in line, side-by-side, then use a piece of tape across all of them at the desired depth to be installed and spray them with a can of graphite. Remove the tape and you'll have a line to drive the guide to every time, and the graphite helps to prevent galling during installation.

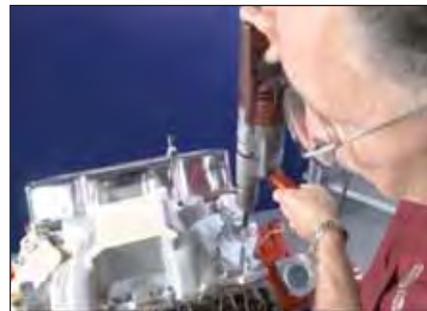
Figure 2 Attach a drill to the end of a priming tool and spin oil pump at a minimum of 500 rpm until oil reaches rockers.

distributor drive shaft into the engine and engage the oil pump drive shaft. Attach a 1/2" electric drill to the exposed end of the priming tool and spin the oil pump at a minimum of 500 rpm. Continue to spin the oil pump until oil reaches the rocker arms. It is a good idea to rotate the crankshaft 360 degrees while spinning the oil pump

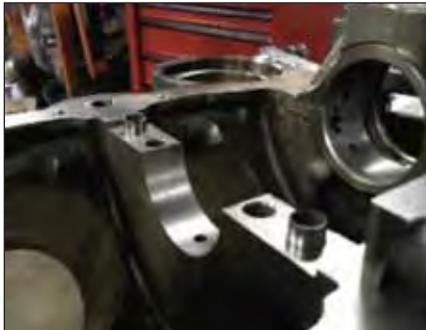
Figure 3 Ream to one half the distance of the dowel, then do the same with the caps. Be sure to sink the holes at least .015" to keep from bottoming the dowels into the cap.
